OHIO RIVER BASIN
FOUR-MILE RUN, WESTMORELAND COUNTY

PENNSYLVANIA
FOUR-MILE RUN DAM

NDS I.D. No. PA - 00457
PENNDER I.D. No. 65 - 126

PHASE I INSPECTION REPORT
NATIONAL DAM INSPECTION PROGRAM

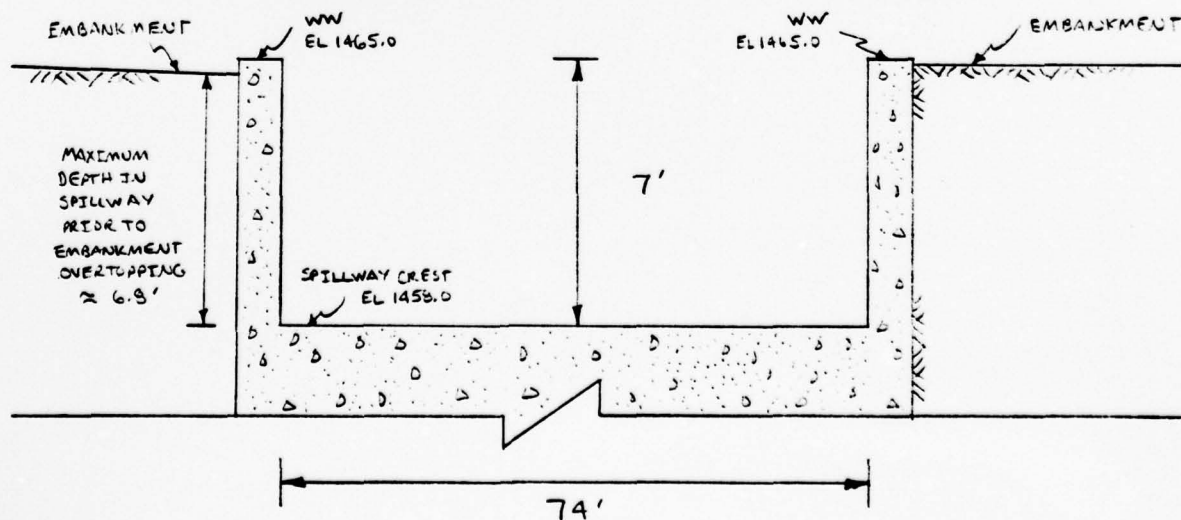
- CROSS-SECTION OF SPILLWAY : (NOT TO SCALE)
 (OBTAINED FROM FIELD MEASUREMENT AND OBSERVATION, AND FIGURES IN APPENDIX F)

SECTION TAKEN LOOKING UPSTREAM TOWARD SPILLWAY

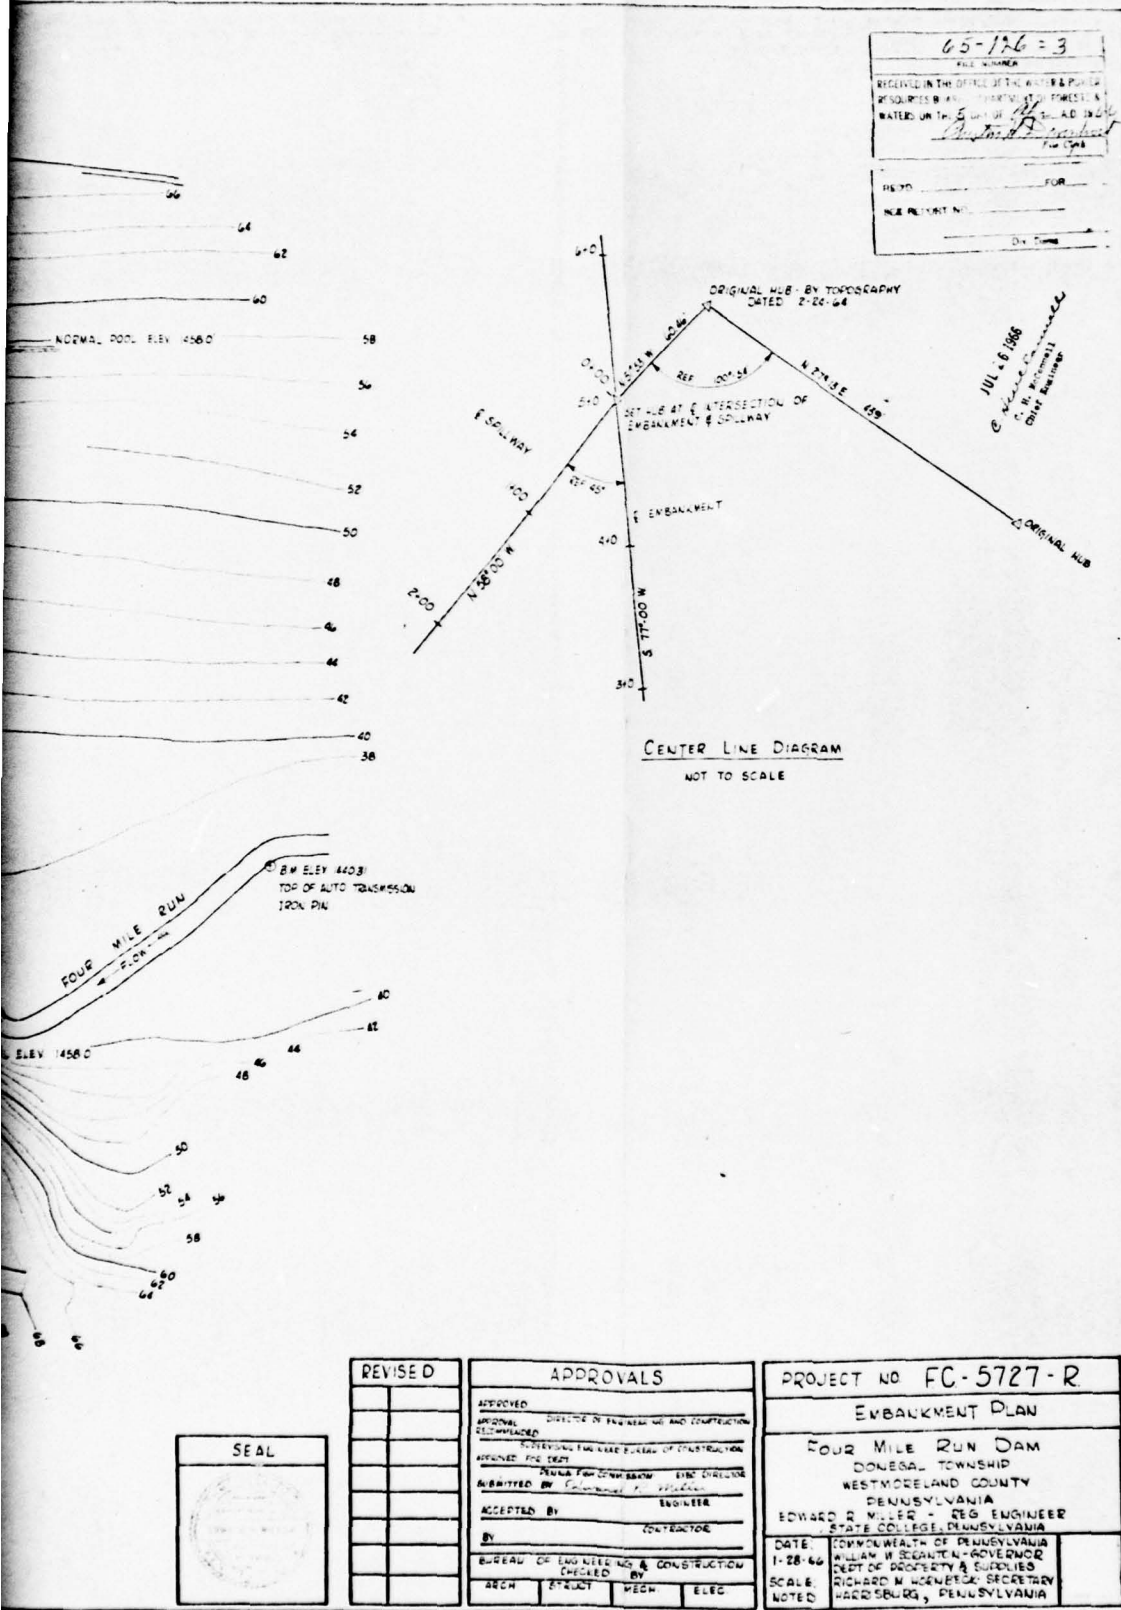
FIGURE 3

R_h = HYDRAULIC RADIUS = FLOW AREA / WETTED PERIMETER
 FLOW AREA = $A_a \approx 1076$ FT², RIGHT WALL OF
 APPROACH CHANNEL IS ON A 2H TO 1V SS
 THROUGHOUT MOST OF ITS LENGTH AND VARIES TO
 0 FT HEIGHT @ THE ENTRANCE (FIG 3 AND 6),
 LEFT WINGWALL AVERAGES A 6.7 HEIGHT (FIG 8)
 \Rightarrow WETTED PERIMETER ≈ 100 FT + 6.7 FT + 11 FT
 ≈ 117.7 FT $\Rightarrow R_h \approx 1076 \text{ FT}^2 / 117.7 \text{ FT} \approx 9.1$ FT

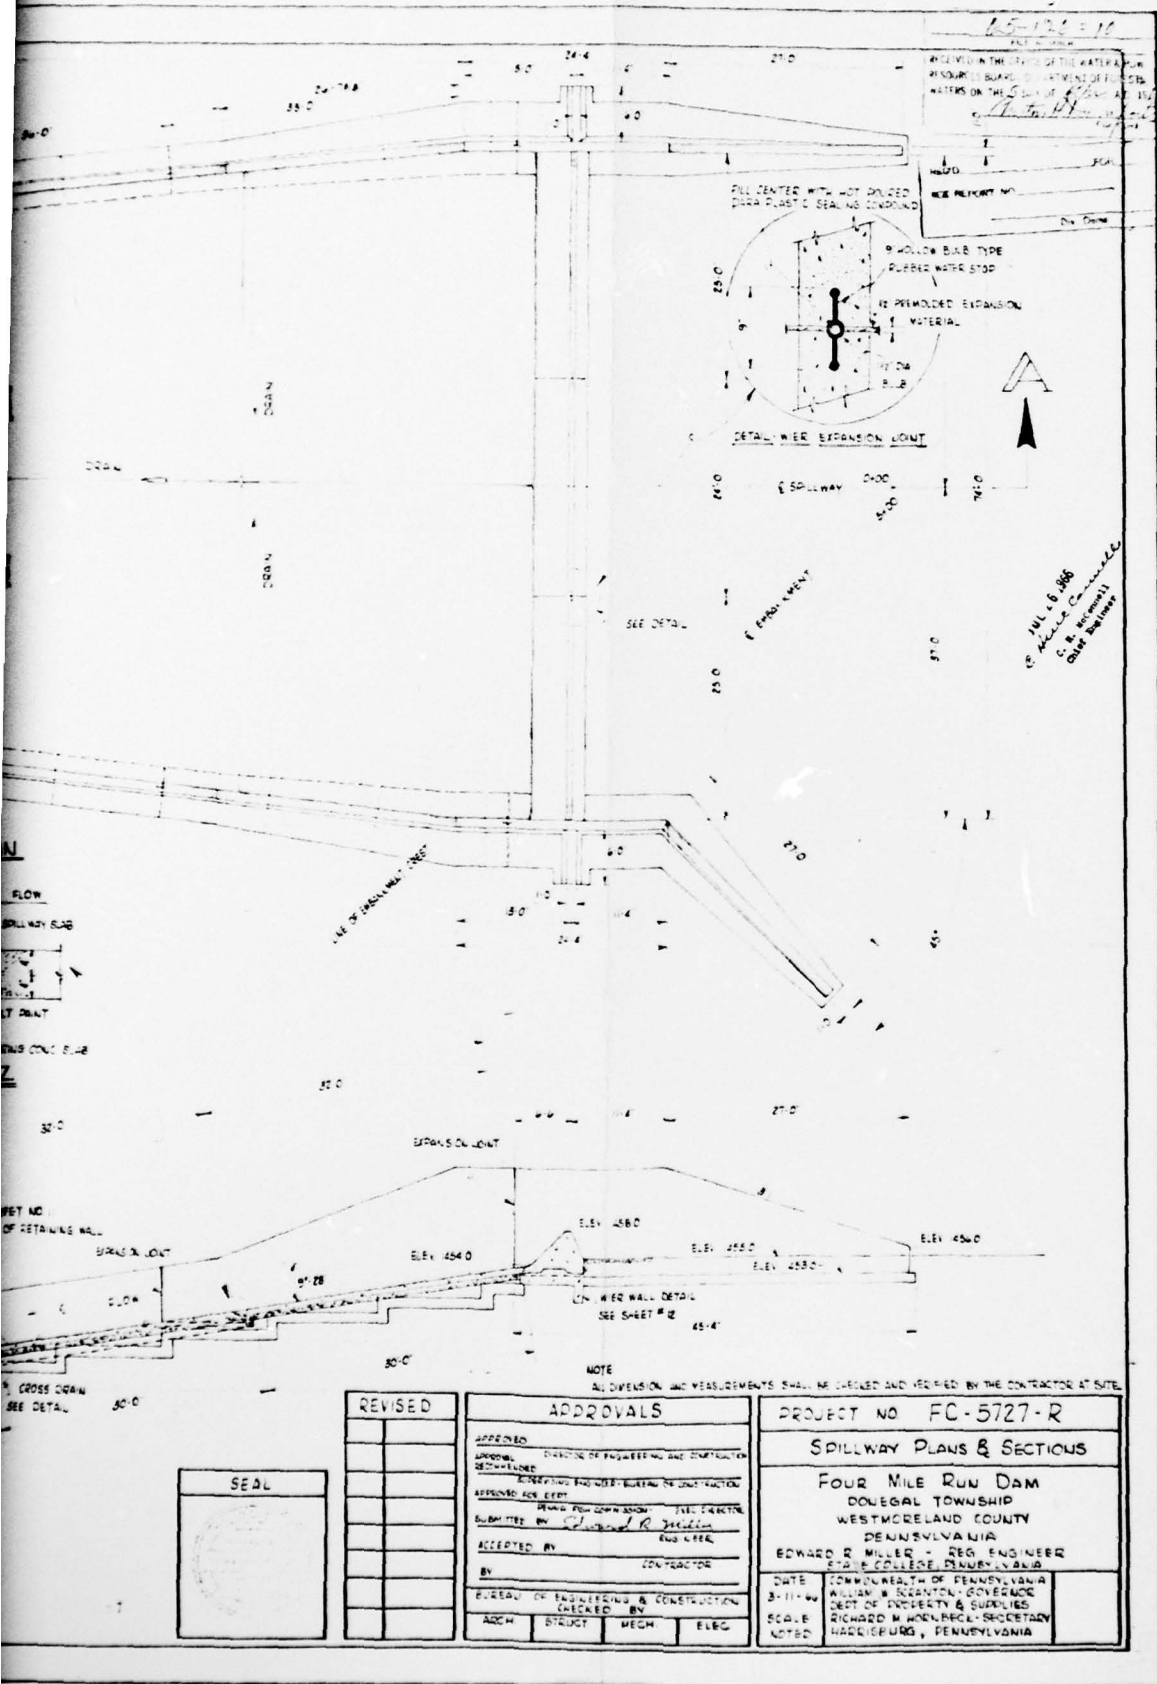
FIGURE 8

a) Spillway. The spillway at Four Mile Run Dam is a reinforced concrete chute channel with a trap-ezoidal-shaped overflow weir located at the right abutment. The chute is 127 feet long from the toe of the weir to the stilling basin. The crest length of the overflow weir measures 74 feet and is flanked by vertical concrete wingwalls that provide 7 feet of freeboard (see Figures 3 and 8).
